# A case study of long-term geochemical evolution of coal waste rock drainage and its remediation

Adam Jarvis

IMWA 2010, Nova Scotia, Canada

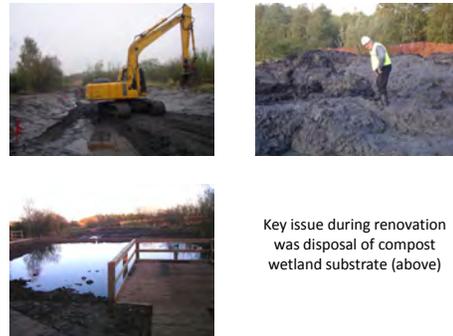
**Wetland system renovation**

Key issue during renovation was disposal of compost wetland substrate (above)

- British Standard (BS) leachability tests showed substrate could be disposed of as 'inert' waste (concentrations below Waste Acceptance Criteria (WAC) as inert waste).
- Note that iron and aluminium not required determinants for leaching tests (but Fe present at ~ 60 000 mg/kg)
- Disposal as inert waste significantly reduced overall costs of renovation
